Manhole Inspection Summary

Manhole # S15MM1009MH

Insp Date: **12/5/06 11:20 AM**

Location Address: **4560 FINNEY AVE**

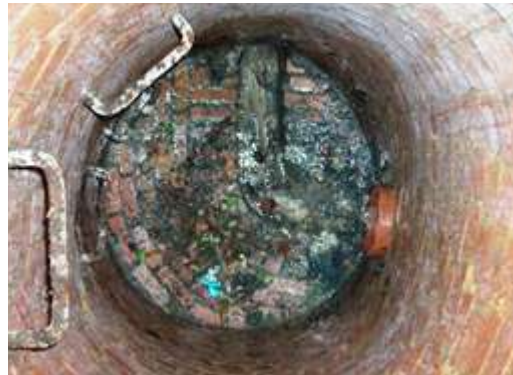
Top View

Adjustment and Barrel infiltration.
Evidence of surcharge - Bench debris.
Channel debris.

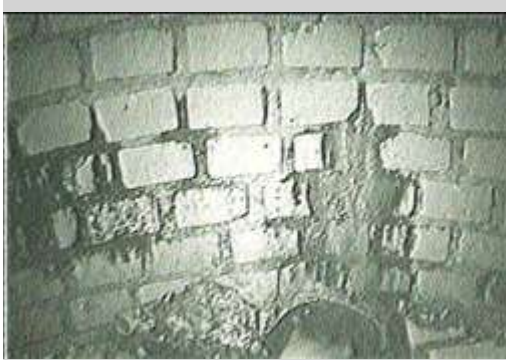
Defect

Barrel infiltration.

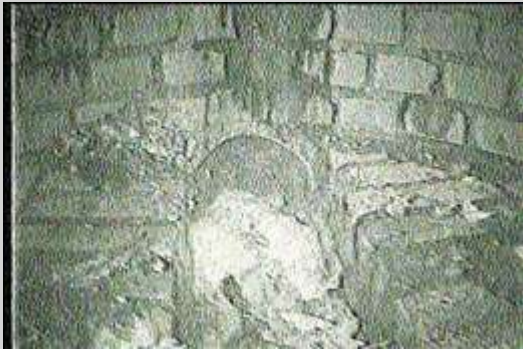
8 in. Circular Gravity Sewer Pipe Out @ 12 O'Clock

Invert Depth: **9.00** (ft.) Flow Characteristics: **Slow**

Infiltration: **None** Pipe Seal Cond: **Unknown**

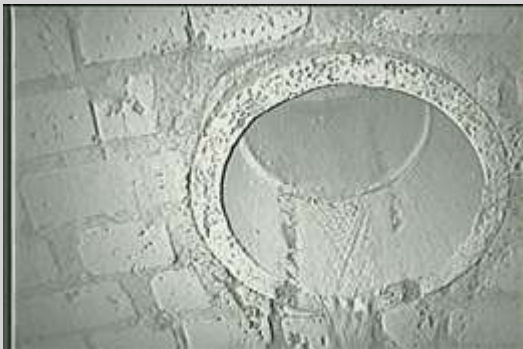
8 in. Circular Gravity Sewer Pipe In @ 3 O'Clock

Invert Depth: **6.75** (ft.) Flow Characteristics: **Slow**

Infiltration: **Evidence** Pipe Seal Cond: **Unknown**

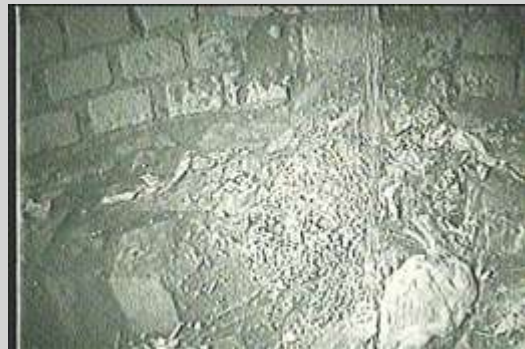
Drop In @ 3 O'Clock

Debris covering Extension

Drop Condition: **Clogged**
